CURRENT CONDITIONS

WATERSHED CONDITIONS

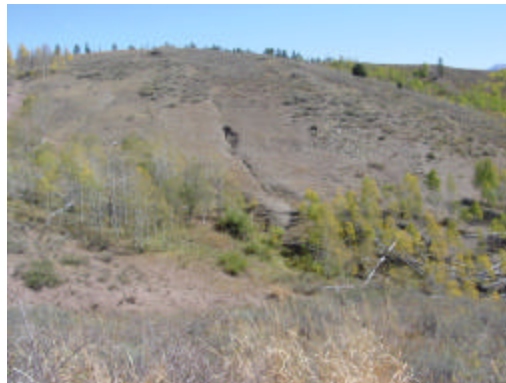
Some geologic parent materials have more potential to erode than others. The Wayan Formation, Twin Creeks Formation, and Preuss Formation all tend to have high natural erosion potential. Figure 3 is an example of erosion occurring on some of these geologic formations.

Figure 34: Gully erosion occurring on the Wayan Formation.

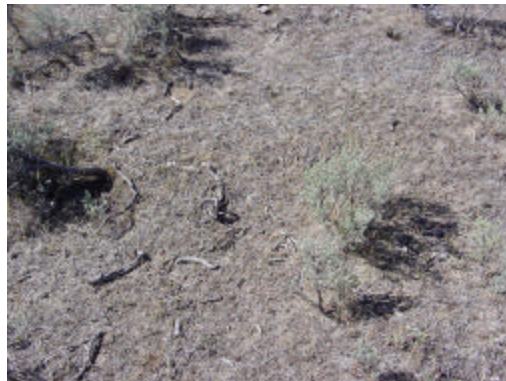
Figure 35: Ground cover in the Fall Creek Basin averaging 90 to 95 percent cover on a mountain big sagebrush/Idaho fescue site.

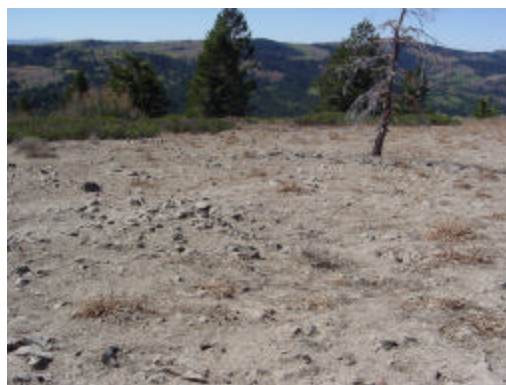
Figure 36: Sheep bed ground on Commissary Ridge where ground cover has been reduced to less than 40 percent on a mountain big sagebrush/Idaho fescue site.

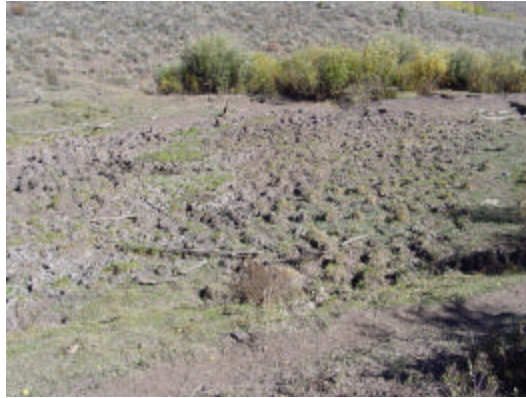
Riparian and wetland areas include areas where free and unbound water is present at least seasonally in the upper soil profile. According to the 1997 Properly Functioning Condition Assessment of the Caribou National Forest that includes the Fall Creek watershed, hydrologic function in nearly all sub-basins has been altered or disturbed. Trampling of riparian soils by livestock was observed in some locations within the watershed. Some areas where stream banks had been trampled by livestock were also documented. Figure 7 shows an area in Camp Creek that has been trampled by livestock.

Figure 38: Riparian area in Camp Creek that shows livestock trampling that has resulted in pedestals.

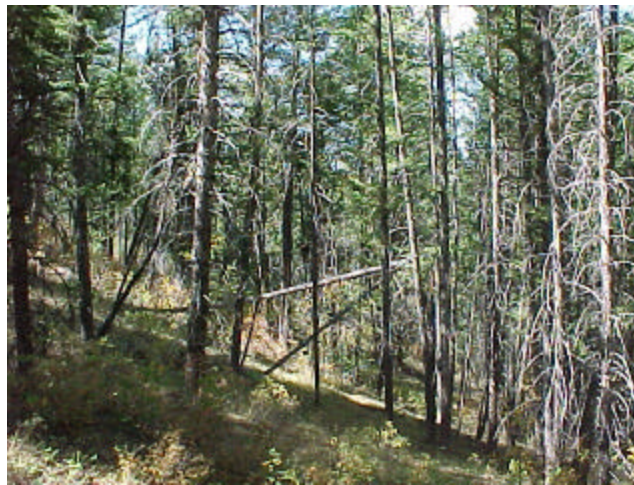
Figure 45: Overall identification picture Rash Canyon.

This photo indicates low ground fuel loading but high ladder fuels in the overall area.

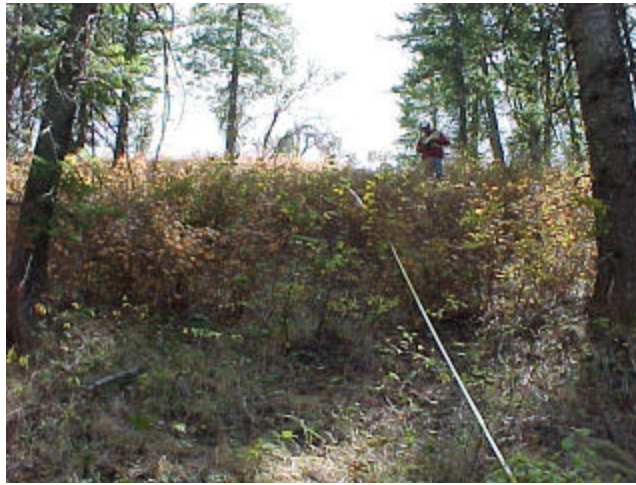
Figure 46: Rash Canyon Plot #1- 2.421 Tons/Acre
Herbaceous Fuels

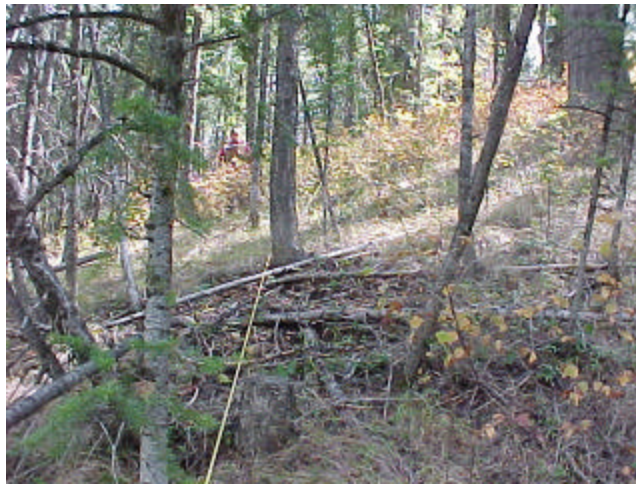
Figure 47: Rash Canyon Plot #2
Herbaceous and down dead fuel loading.

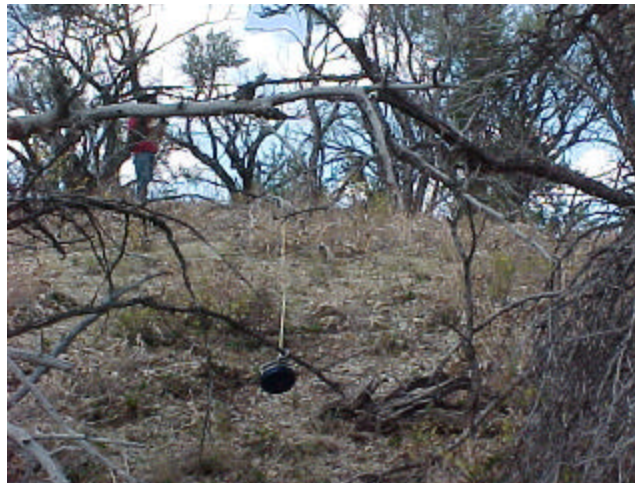
Figure 48: Rash Canyon Plot #6 – 10.094 Tons/Acre
Herbaceous, Shrubs, Litter and Down woody debris.

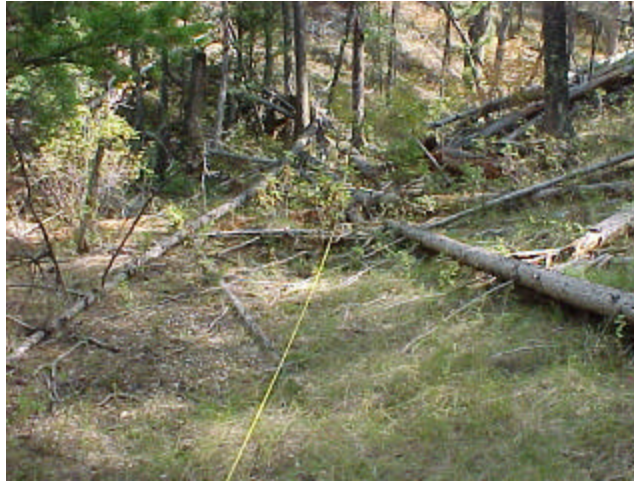
Figure 50: Rash Canyon Plot # 9 – 25.345 Tons/Acre
Grass, shrubs and heavy concentration of down dead woody debris.

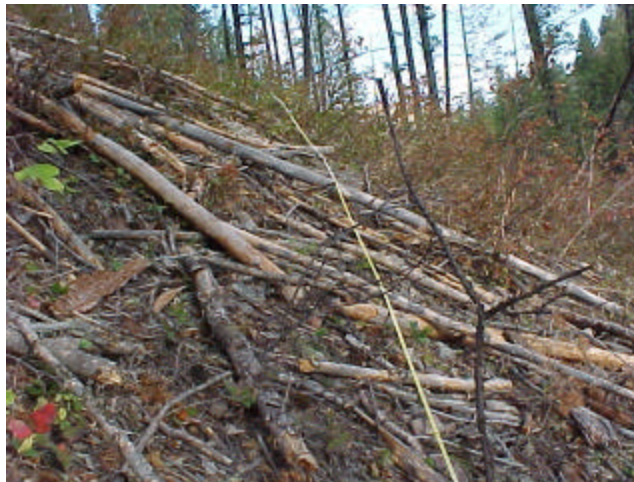
Figure 51: Rash Canyon Plot #13 – 38.292 Tons/Acre
Heavy fuel loading of down woody debris.

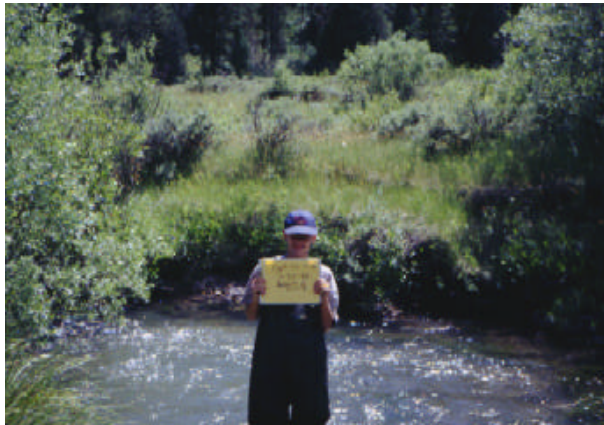
Fall Creek was surveyed by the Caribou-Targhee National Forest Fisheries Crew in 1999 (USDA Forest Service 1999). The lower valley riparian vegetation was dominated by a wet willow, hawthorn, and sedge/grass community with lesser amounts of sagebrush. The surrounding slopes were dominated by grasses and a low shrub layer with little cover value. The lower reach (from Echo Canyon to Calf Hollow) was a C3 Rosgen type with a well developed floodplain. The stream was moderately entrenched, with a relatively sinuous meander. Mineral seeps were apparent throughout the eastside of the riparian edge adjacent to Little Current Hollow. The upper reach appeared to be moderately unstable with high bank and stream channel erosion documented. Stream channel stability for the entire stream was rated as good.

Figure 55: Typical lower Fall Creek during 1999 fish distribution survey.

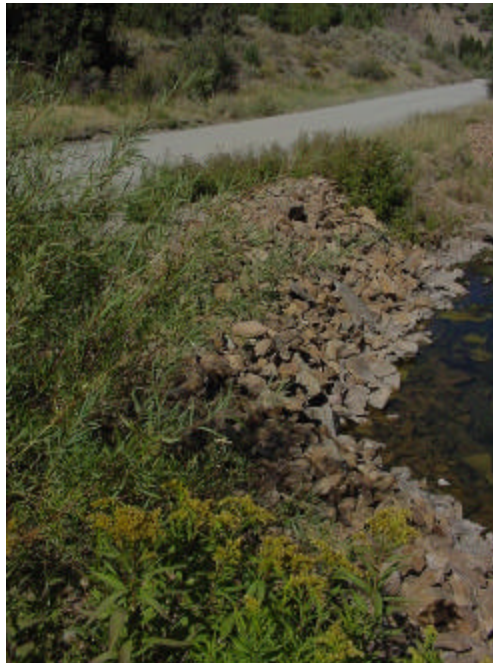
FS Road 077 parallels Fall Creek along its lower 8.2 miles. Road segments share road shoulder with stream bank. This road encroachment upon the stream is a source of road sediment to the stream and impacts the quality of the riparian area by decreasing riparian vegetation and shading. Rip rap has been applied to the stream banks at these stream/road interfaces and they continue to be maintained by the county who is responsible for maintenance of this road.

Figure 56: Riprap along Fall Creek Road, September 2001.

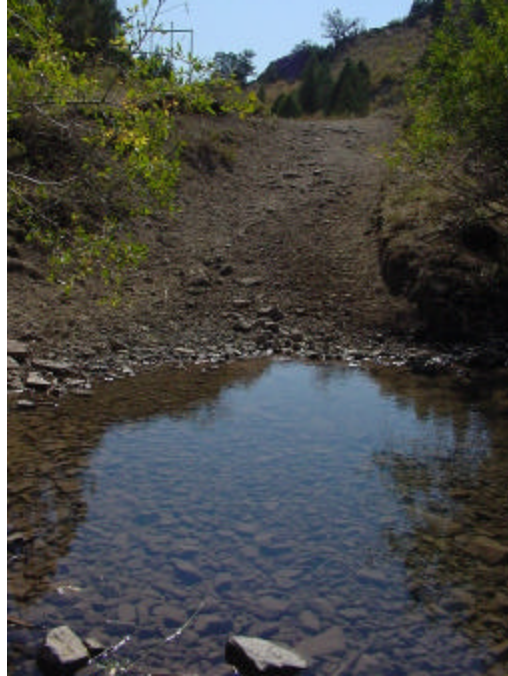
The crossing with likely the most impact upon Fall Creek is the Rash Canyon Ford. The stream has been significantly widened and shallowed at this crossing and the approaches to the stream are sediment sources.

Figure 57: Ford through Fall Creek at Rash Canyon, September 2001.

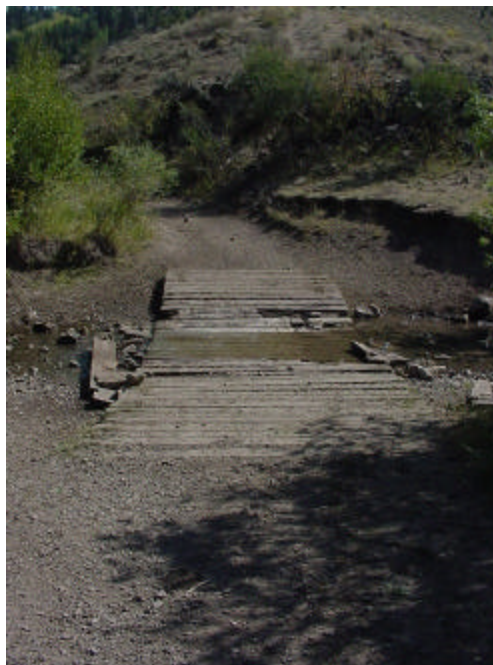
Figure 58: Ford through Fall Creek at South Fork, September 2001.

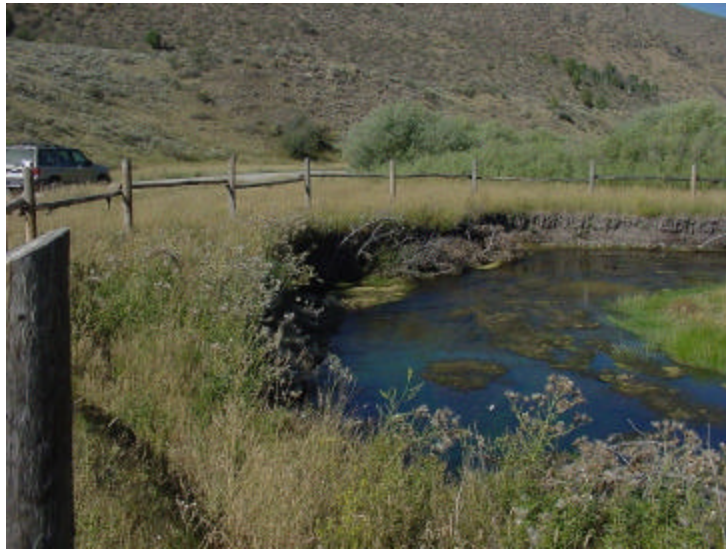
Figure 59: Results of a past streambank stabilization project, September 2001.

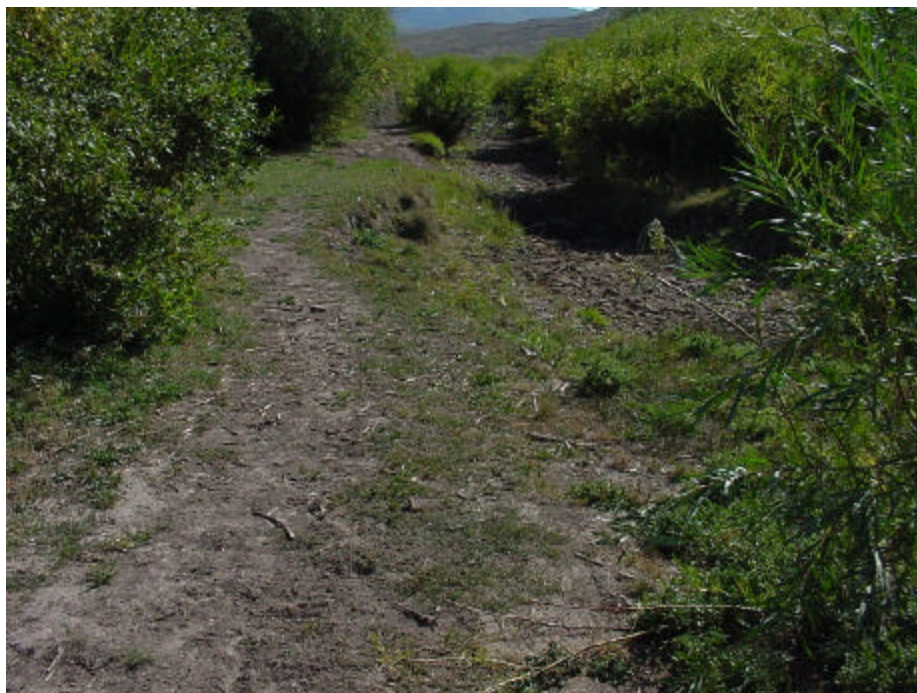
Figure 60: Upper Fall Creek Road/Trail. Note bare soil and proximity to Upper Fall Creek. Upper Fall Creek was dry in September 2001.

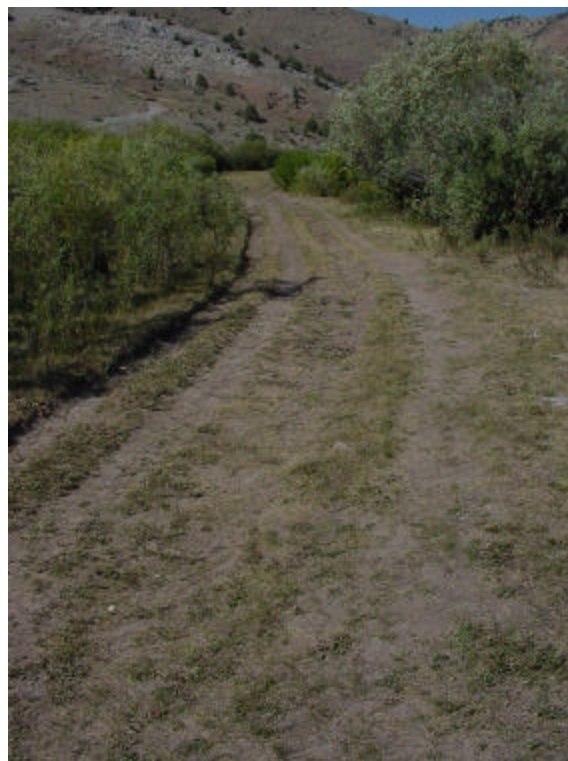
Figure 61: Upper Fall Creek Road/Trail. Note bare soil and rutting.

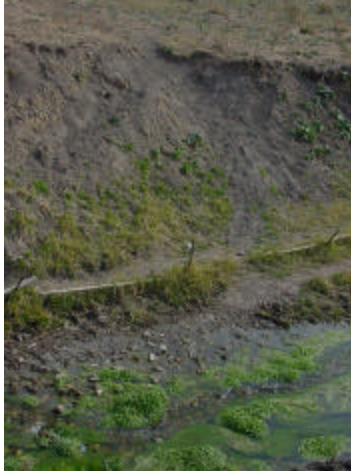
Figure 63: Pritchard Creek near old reservoir bed, 9/01. Note thin tree stems and metal posts left from past restoration project. Also note cattle trampling and stream sedimentation and nutrification.

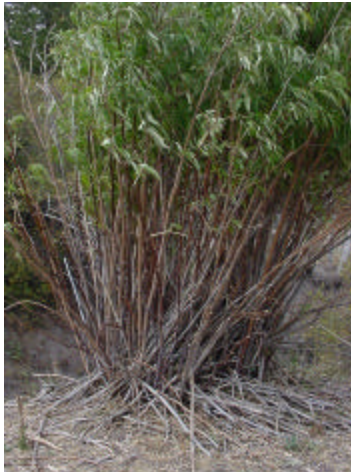
Figure 64: Woody riparian species grazing and highlining in Pritchard Creek upstream of exclosure, 9/01.

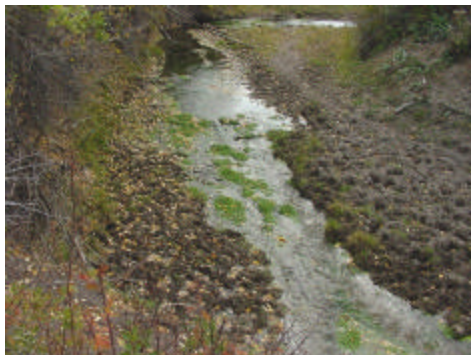
Figure 65: Riparian area trampling and stream widening by cattle in Pritchard Creek, 9/01.

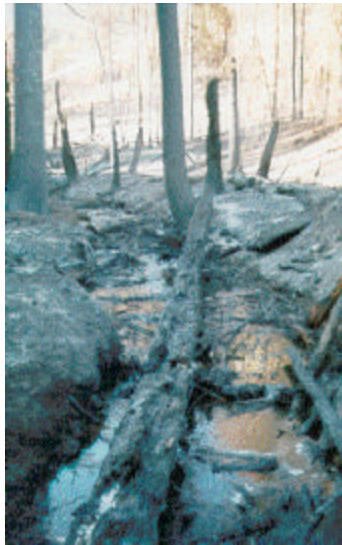
Figure 66: Burned riparian area along Garden Creek, 10/99.

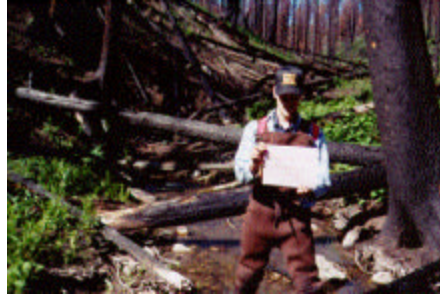
In June 2000, the Caribou-Targhee National Forest Fisheries Crew returned to Garden Creek to monitor the effects of the fire by revisiting their 1999 fish distribution survey units. Reach 1 was unaffected by the previous year's fire. The riparian vegetation was still dense and consisted of red osier dogwood and willows in the understory and lodgepole pine and Douglas fir in the overstory. High levels of fine sediment were observed in the stream substrate, although the dominant substrate was gravel and cobble. This fine sediment was a likely result of the fire upstream. Reaches 2 and 3 were affected by the fire. In many places, the riparian area had been completely incinerated by fire, where it used to consist of thick alders, hawthorn, and willows. Burned lodgepole pine and Douglas fir occurred in the overstory. The understory was dominated by thistles, but willows and forbs were beginning to reestablish. Each reach was rated for stream channel stability and found to be good to fair (USDA Forest Service 2000).

Figure 67: Garden Creek in burn, 1 year after, 6/00.

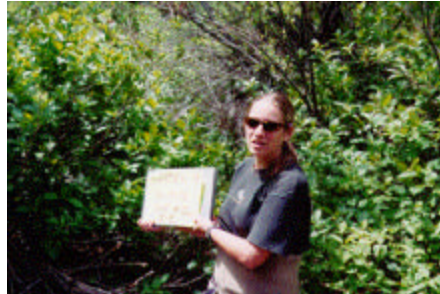
Figure 68: Garden Creek in unburned area, 6/00.

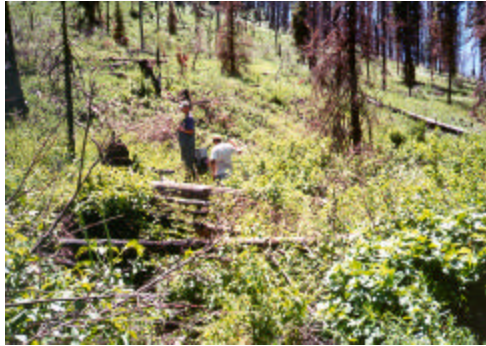
Figure 70: Upper Garden Creek within the burn. Note extensive vegetation regrowth, 7/01.

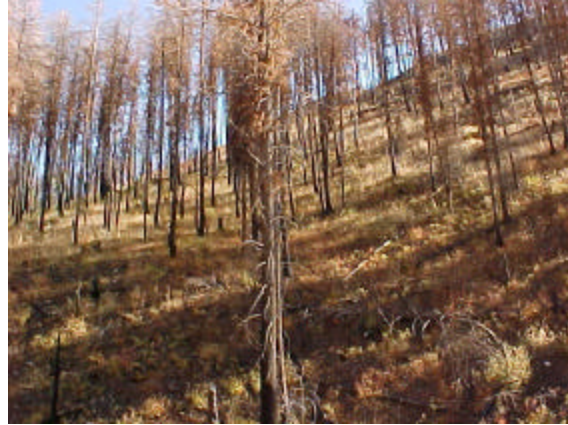
Figure 77: Shows north slope conifer burned in fall 1999 fire. Photo is 2 years later with regrowth of native grasses, forbs and browse (eg. snowberry) in understory.

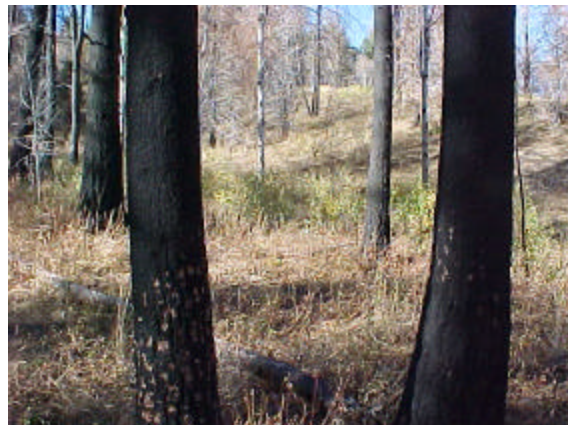
Figure 78: Garden Creek 1999 fire removed conifer competition for aspen. See the new growth of sprouting quaking aspen clones which was released.

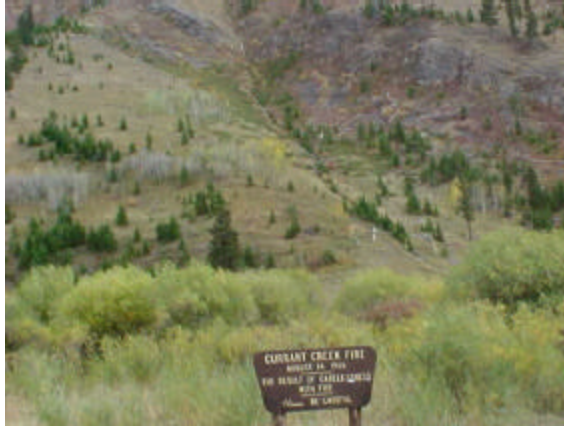
Figure 79: 1966 Currant Creek wildfire that burned in Fall Creek. This photo is 35 years later in the fall of 2001. Willows along the Fall Creek riparian area are in the foreground.

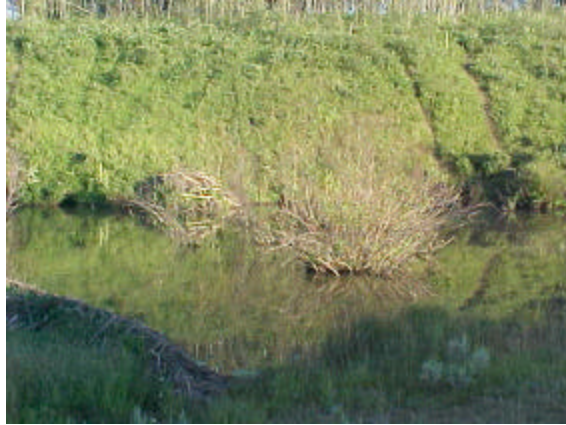
Figure 80: In Trail Creek in the upper Fall Creek watershed beaver have logged the aspen clones back a good distance from the streamside.

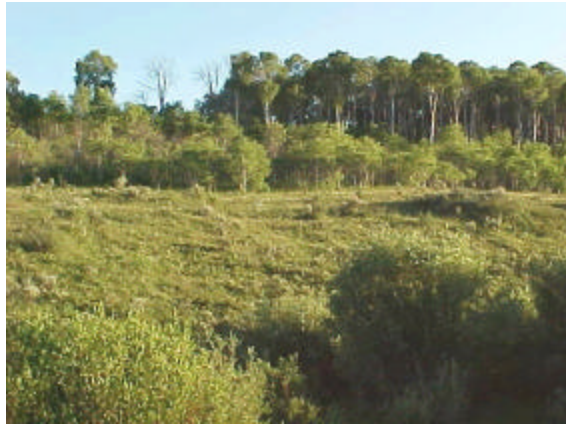
Figure 81: Note the larger and older aspen that have not been impacted. It does not appear that livestock grazing has been a major problem here since the aspen clones are still re-sprouting.

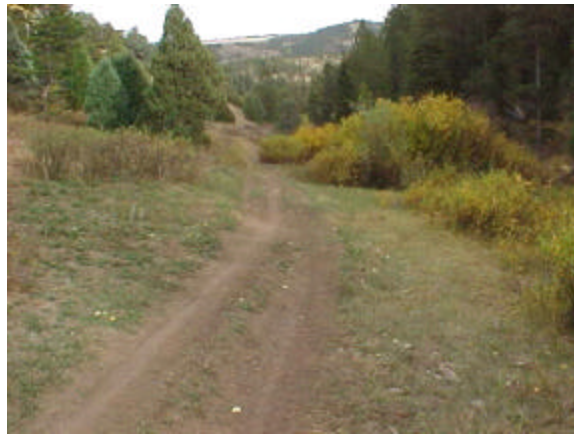
Figure 91: This trail in the Fall Creek upper drainage was an original horse trail that became a popular motorcycle trail in the 1980's and before. Currently, it is being made into an ATV trail by continued use. This is allowed under the new Targhee Forest Travel Plan (2000) which allows ATV use on all designated numbered trails whether they are wide enough or not, but this trail is not recommended for ATV use.

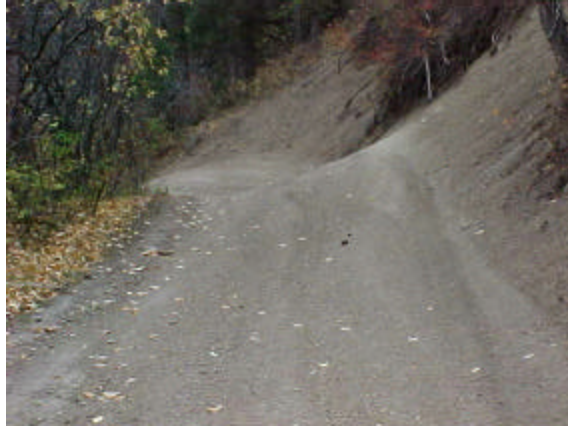
Figure 92: Roads like this one began as jeep trails created by hunters and ranchers that were often located next to streams and on inappropriate terrain. This old jeep trail is now a FS system road that is causing inroads to elk habitat and providing access to many illegal roads and ATV routes that branch off from the legal ones.

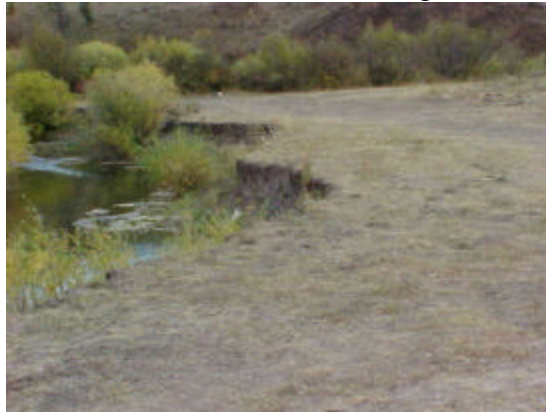
Figure 93: An eroding stream bank in the Fall Creek riparian willow habitat that is negatively influenced by motorized dispersed camping. The Travel plan allows camping and woodcutting within 300 feet of any legal road or trail as long as vegetation is not damaged.

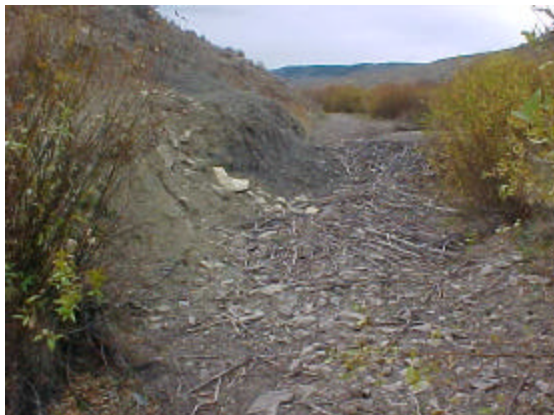
Figure 94: This is a dry side channel of upper Fall Creek in late summer which has become an illegal motorized trail. ATVs and motorcycles are driving over the existing beaver dam scattering materials in the channel to travel this route.

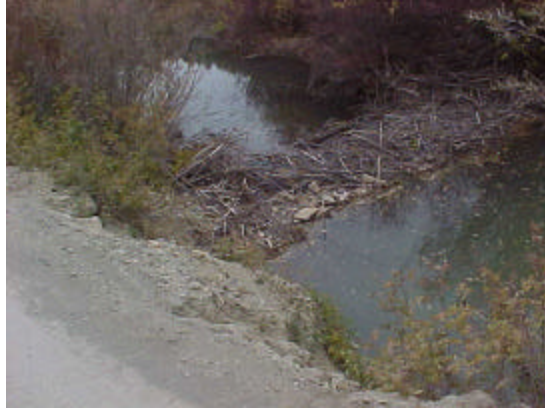
Figure 95: Much of the Fall Creek road (077) displaces beaver and other wildlife habitat and conflicts will continue to occur until a road like this is relocated up and out of the riparian zone. The FS has given the right of way ownership of this road to Bonneville County and they now control the use and maintenance of it. Cooperation with the county will be needed for future wildlife protection or management here.

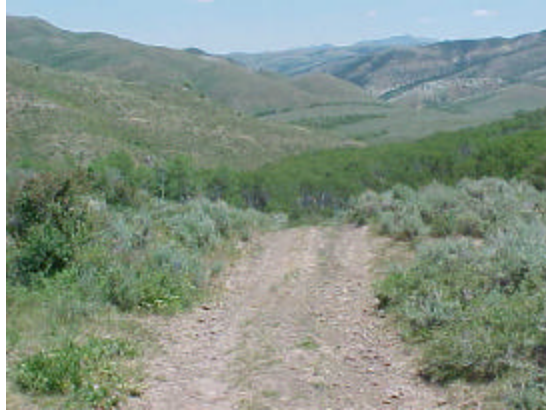
Figure 96: An example of an old jeep road not present in 1952 aerial photos that is present today.

Distribution of motorized routes in parts of the watershed are not good for maintaining elk during the summer – fall seasons. Illegal as well as legal roads and trails are found on many ridgetops and along many stream bottoms in the watershed. This scenario is one some researchers have found damaging to elk habitat (Rowland et al. 2000; Edge and Marcum, 1991). The motorized use in the watershed is also not managed intensely. Funding for proper law enforcement and barrier engineering has not been forthcoming. Cole et al (1997) found that elk movements decreased when vehicular access was tightly regulated and suggested that overall herd fitness would improve with reduced disturbance. Funding for improving roads have been more readily available and some have been turned over to local county management (eg FS 076 and 077) who have other funds to do the maintenance and upgrading.

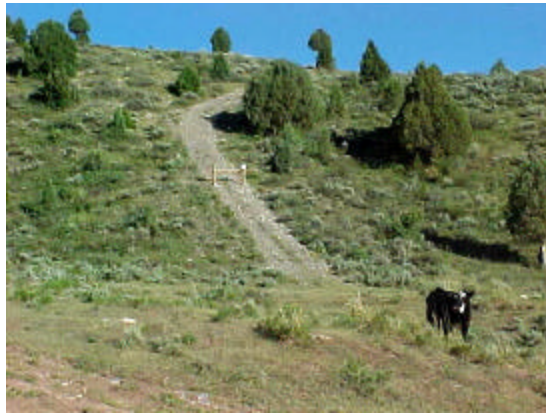
Figure 97: A new and well established illegal cross country ATV route in Fall Creek. For every legal road and trail there is a multiple factor of illegal trails in the motorized system. This one currently has a fence barrier and sign. Many users do not know it is illegal and others who do remove signs and barriers so the habitat damage continues. This route also has illegal snowmobile use in big game range in the winter.

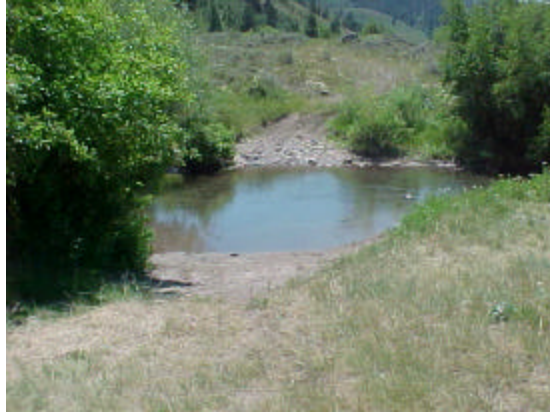
Figure 98: Illegal cross-country route going across Fall Creek riparian habitat located just downstream of the confluence of South Fork Fall and Fall Creeks.

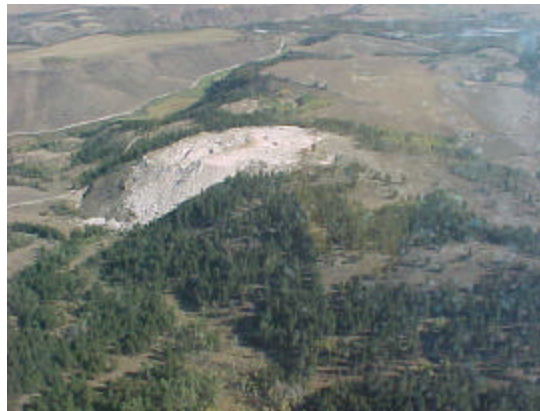
Figure 99: Idaho Travertine rock mine. It displaces about 60 acres of game winter range, but provides stone for fine construction rock facing on buildings.

There are currently influences from grazing which is probably ranks second next to motorized and hunting recreation activity for effects on wildlife and habitat, particularly riparian habitat. Refer to riparian and motorized sections. Mining influence on wildlife in these watersheds has been minor as has been logging. There have been a few phosphate exploration digs in Garden, Pritchard and Fall Creeks. A one-fourth mile deep tunnel in Pritchard Creek was closed a few years ago and a bat grate was installed after a survey determined bats were present. A large open rock pit is located in Echo Canyon and has taken about 60 acres of habitat from winter range.

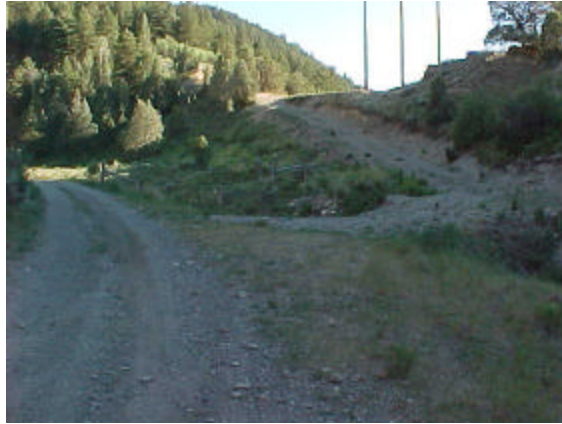
Figure 100: New powerline road built off the Rash Canyon Road to access power poles on the BPA line in Fall Creek. BPA will also be building a culvert across Fall Creek soon to service this road that will provide easier access up Rash Canyon that leads to a large network of legal and illegal motorized trails in the watershed. Currently, the ford crossing on Fall Creek inhibits both summer and winter vehicles. The Rash road is not a designated route in winter range.

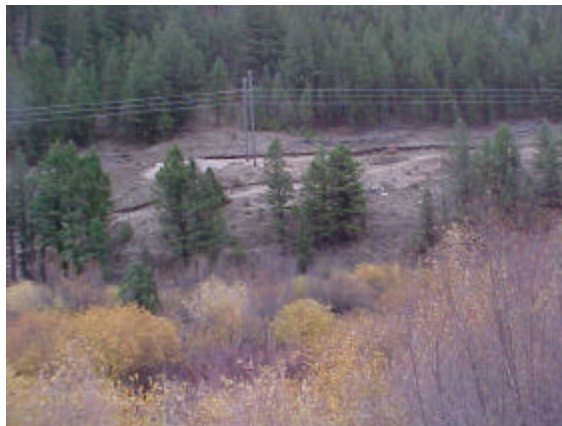
Figure 101: An example of the powerline access roads along the Fall Creek stream corridor. These roads do not count in the Forest Travel plan road density, because they are administratively closed, but they do not have any barriers to keep traffic out.

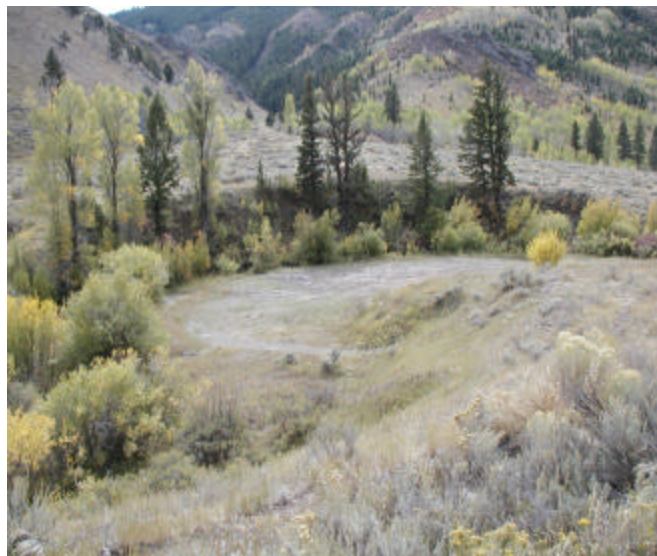
Figure 103: Dispersed camping site adjacent to Fall Creek.

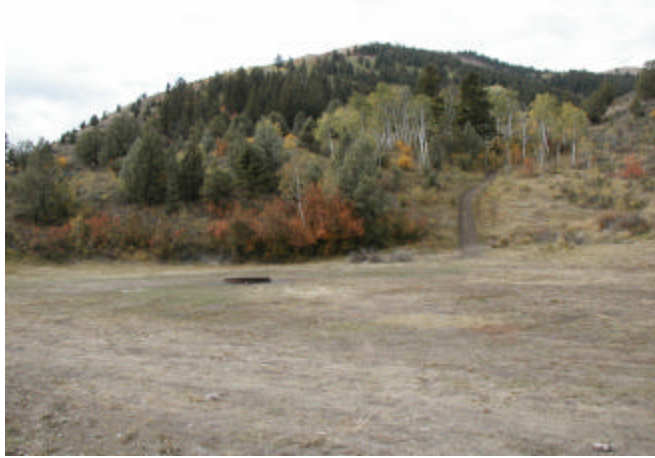
Figure 104: Group dispersed camping site near Echo Canyon along Fall Creek Road

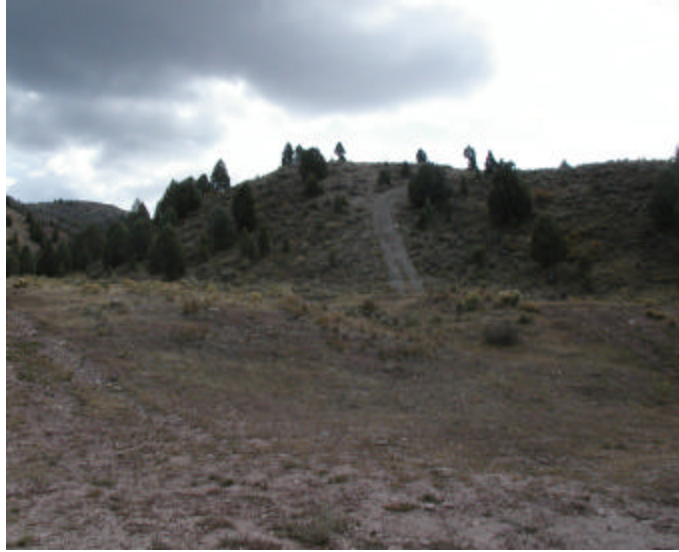
Figure 105: Illegal hill climb along Fall Creek Road. This one was made by 4x4 truck, many are single track motorbike trails.
